TEMPLES LAKE DAM
STODDARD COUNTY, MISSOURI

MISSOURI INVENTORY NO. 40065

PHASE I INSPECTION REPORT
NATIONAL DAM SAFETY PROGRAM

MARCH 1980

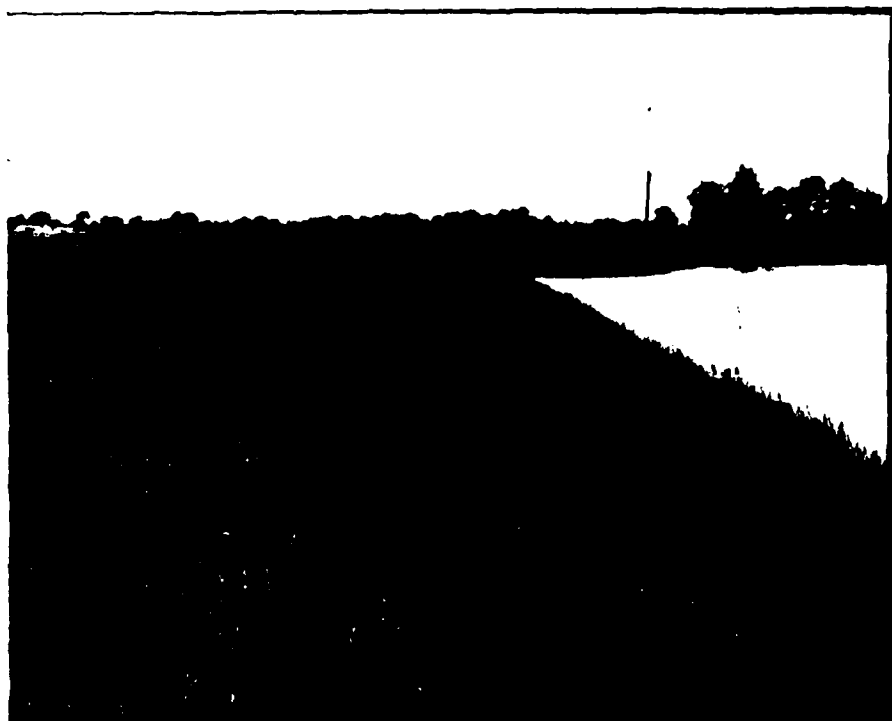
c. Dam. Based on the cross-section presented on Plate 5, the dam has an average upstream embankment slope of 1V on 3.54H and an average downstream slope of 1V on 3.12H. The crown width of the dam is 13 feet. The visual inspection indicates no evidence of any undue settlement, cracking or sliding of the dam. No animal burrows were observed in the dam. The crest and slopes are very well grassed and maintained. (See Photos 1, 2, and 3).

PHOTO 1: Centerline of Dam from the Left Abutment

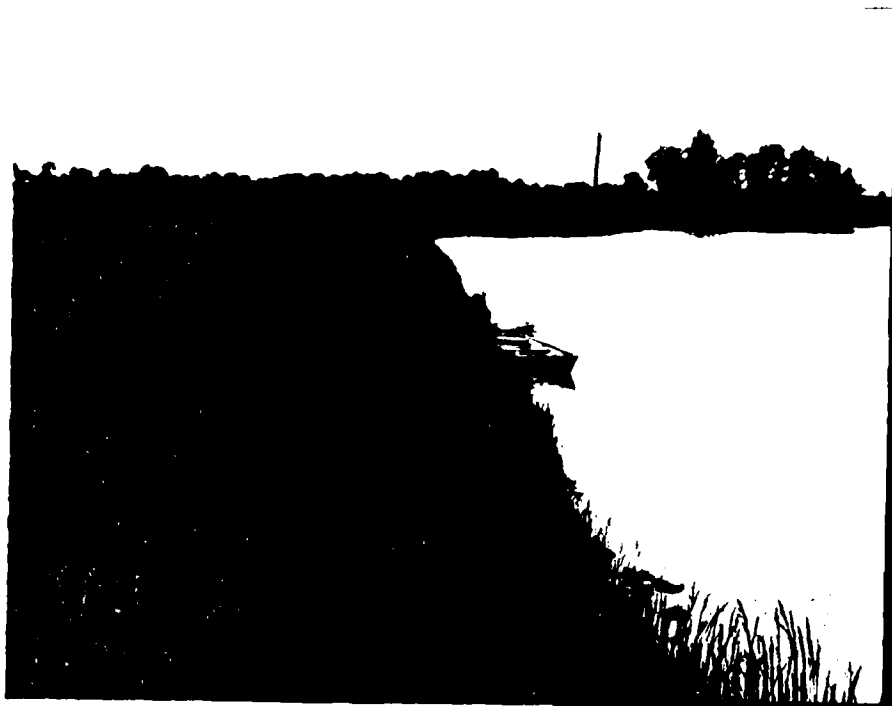
PHOTO 3: Upstream Slope from Left Abutment

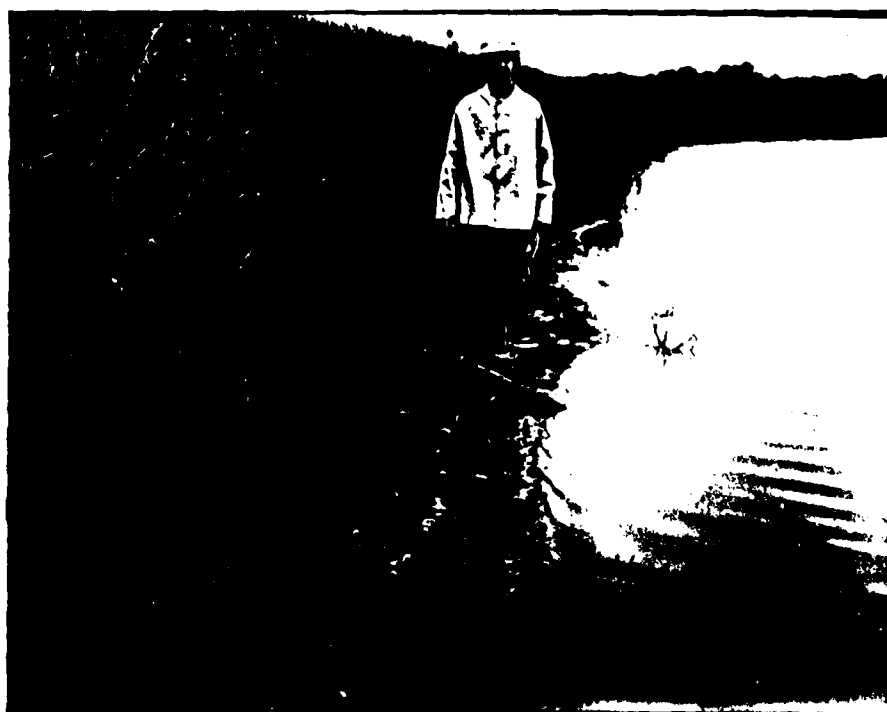
The upstream embankment has no erosion protection and some minor wavewash has occurred intermittently along the upstream face (See Photo 4). Minor erosion appears on the downstream face of dam; however, this appears to have been caused by the use of this portion of the dam by cattle. (See Photo 5). Also a marshy area was observed on the downstream toe of the embankment near the emergency spillway (See Photo 6). No evidence of piping material or seepage flow was observed. The area appeared to be a low marshy area.

None of the conditions observed are significant enough to indicate a need for immediate remedial action. However, the minor wavewash and minor erosion gullies on the downstream embankment slope of the dam should be corrected or controlled.

PHOTO 4: Wavewash on Upstream Slope

(1) The minor wave wash of the upstream embankment slope and the minor erosion gullion on the downstream embankment slope should be corrected or controlled.

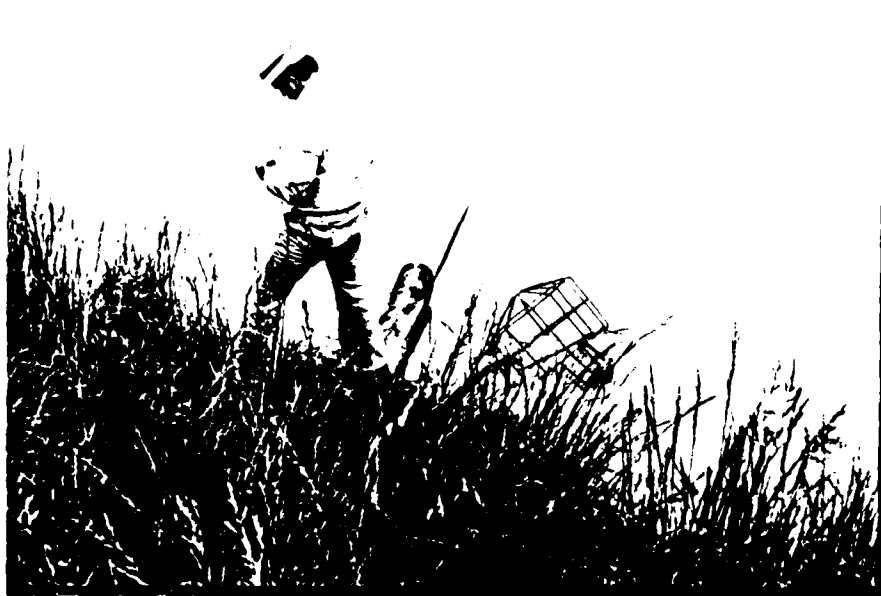
d. Appurtenant Structures. An 8-inch diameter smooth iron pipe with a canopy inlet and trash rack is the primary means of discharge. At the time of the inspection the trash rack had been removed. The lake was also being drained by a siphon constructed of PVC pipe inserted within the main discharge pipe. (See Photo 7). Minor seepage flow with a reddish iron oxide tint was observed in the area of the outlet. No piping of dam material was observed. Willow trees and cattails grew abundantly in the area. (See Photo 8). An earthen V-shaped emergency spillway was cut in the right abutment. The discharge of the emergency spillway empties into a side channel that extends for a distance of approximately 700 feet. The channel then connects to a small farm pond. The emergency spillway and side channel are very well maintained. (See Photos 9 and 10). Plate 6 shows the centerline profile of the top of the guide levee and the centerline of the bottom of the emergency spillway channel from the main dam to the farm pond.

PHOTO 7: Inlet Pipe
